Forensic and Technical Aspects of the VIN Location on Motor Vehicles

Abstract: A vehicle identification number (VIN) is an unambiguous, globally unique vehicle identifier. The paper describes principles for its location on a vehicle, the method of its making (manufacture) and, last but not least, types of protection against negative factors to ensure that its identification value is preserved and, simultaneously, the process of identification inspection of a vehicle is clear, fast and efficient. The text analyses various views on VINs from the viewpoint of vehicle manufacturers, administrative bodies (that use vehicle identification in nationwide vehicle registers) and law-enforcement bodies during the investigation and gathering of evidence of car crime.

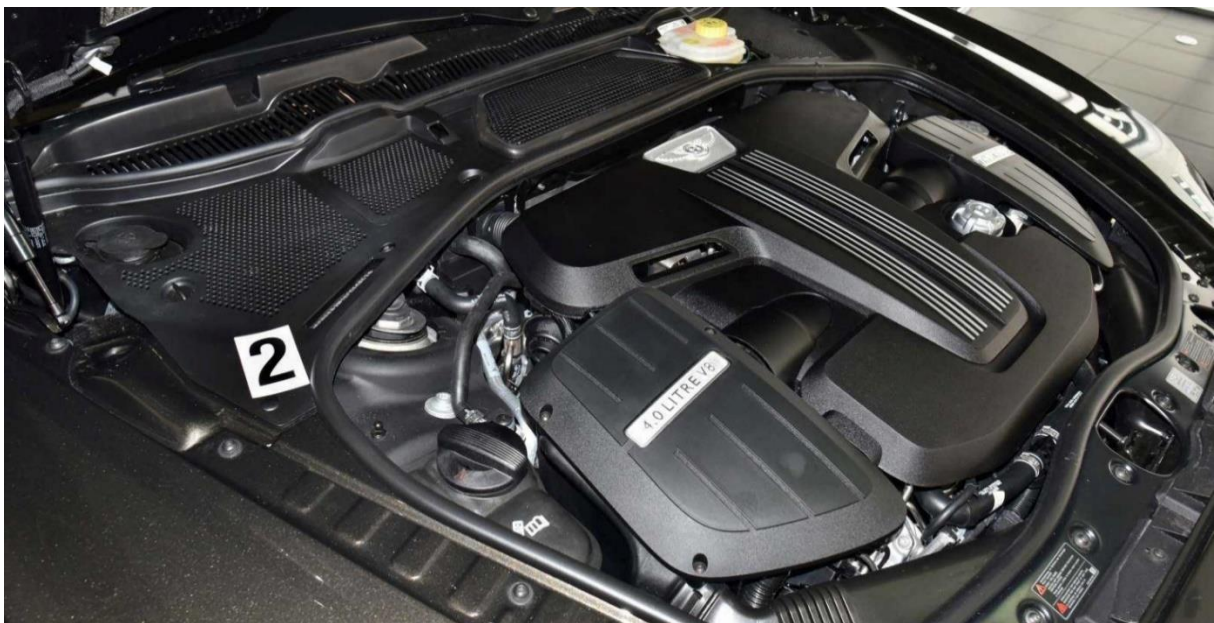
Figure 1. A standard VIN position in the engine compartment of a Bentley Continental GT vehicle. The VIN is easily visually accessible (to the right of number 2).

Aside from certain exceptions, a VIN identifier located **in the engine compartment** usually tends to be well-placed, so it is visible at first sight after the engine compartment lid is opened. VINs have been placed there plentifully in the past, particularly along the upper sides of the body; in the front top part of the dividing partition between the cabin and the engine compartment. A VIN is then rather placed on the left (when one faces an open engine compartment of the vehicle in its front part, opposite the windscreen), or symmetrically based on an imaginary rear-front longitudinal axis of the vehicle. In other cases, the VIN can be found in the left and right top sections of the body to which vehicle wings are attached. Vehicles of the BMW make tend to have their VINs located on shock absorbers.

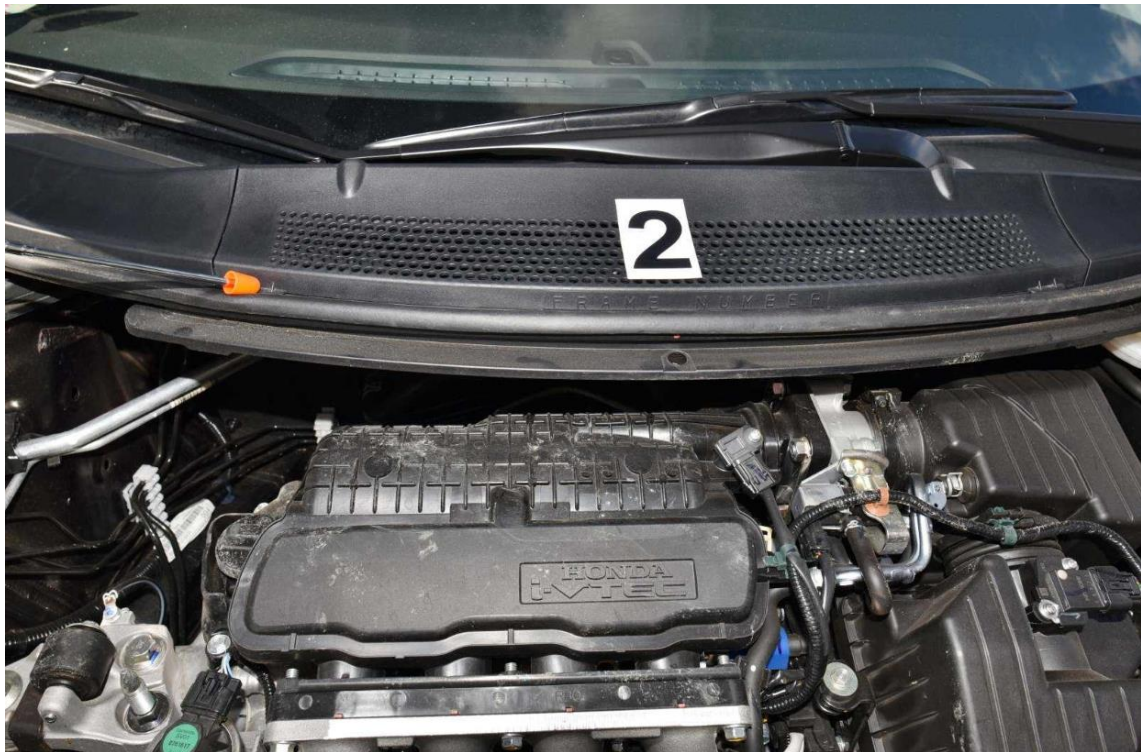
Figure 2. An example of a difficult-to-access VIN in a Honda Civic vehicle. For the identifier to be visually accessible, plastic parts must be expertly dismantled.

- In such a way that it is **readily available (accessible, visible)**. In terms of the availability of a VIN identifier, we differentiate direct, **visual availability by mere sight** or **availability after simple removal** of certain covering parts, components, etc., of the vehicle that can be easily turned aside, opened, bent away, moved, rotated, etc., so the VIN is then easy to visually observe without the need of any specialist knowledge or skills to make it accessible. The simple covering of a VIN has aesthetic reasons (for instance, a VIN cannot be directly seen in the vehicle's interior, in the floor between the front passenger's legs), or in protecting the identifier (from fouling, damage, water access, corrosion, etc.). Other manufacturers position a VIN in a vehicle in such a way that it is first necessary to remove some parts and components of the vehicle and, to this end, it is necessary to either use specialist tools or specially trained persons (e.g. removal of windscreen wipers using special wrenches so that it is possible to take off a plastic cover under which the identifier is physically located). This is referred to as **availability of the identifier by means of a professional intervention**. However, such procedure denies, in a certain sense, the idea of good accessibility of the VIN that is necessary for approximate identification of the vehicle if one does not know where to look for the VIN that is hidden under parts or components of the vehicle at all.

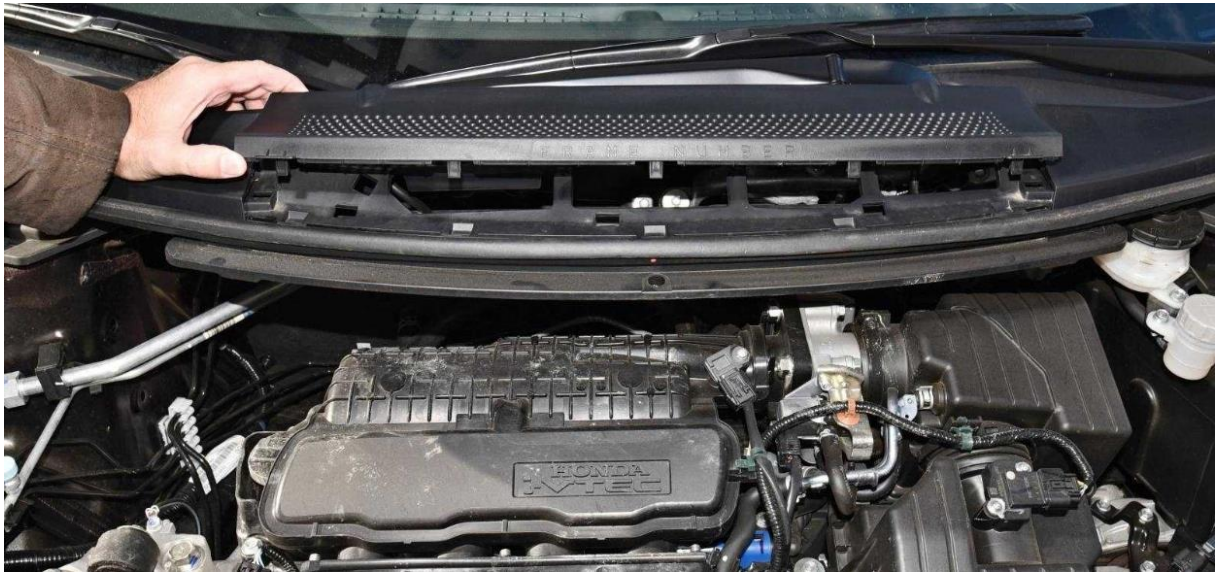
Figure 3. Demonstration of a dismantled plastic cover in the space in front of the windshield wipers.

In the engine compartment, the VIN identifier is usually protected by a mechanical covering in the dividing space between the engine section and the cabin of the vehicle. In this case, the VIN tends to be placed near the bottom edge of the vehicle's windscreen (e.g. some Peugeot, Citroen and Honda cars). The covering tends to be either plastic (similar to the solution described above) or even made only of a soundproofing material which covers the engine bonnet. For strengthening by powder-actuated metal clips, the soundproofing material may be attached to the base material, which resembles a paper carton. The VIN covering is attached by means of a swivel pin and is thus unscrewed upwards, or may even only be on hook-and-loop fasteners.

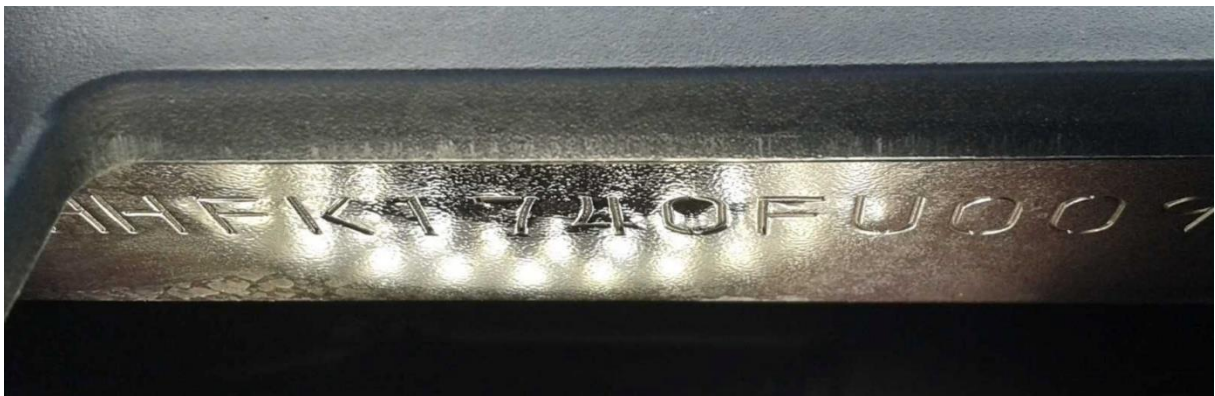
Figure 4. Overall, the identifier is visually inaccessible even following this dismantlement. Reading the VIN is very uncomfortable, and the inclined surface plays a role as well.

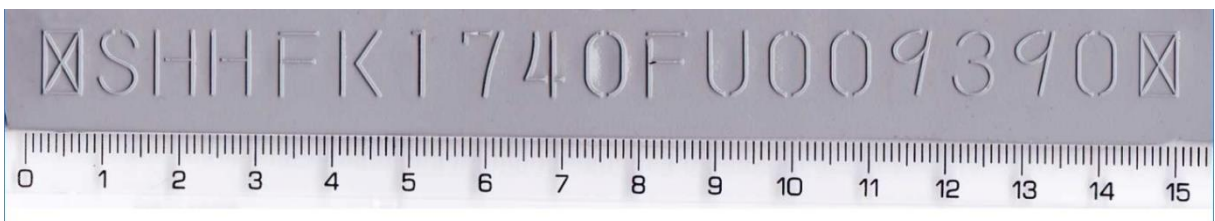
Figure 5. In forensic practice, plastic prints by means of a special compound (ISOMARK in this case) are used in such cases for documentation purposes. They are very sensitive and make it possible to observe the print in detail in its detailed form afterwards.

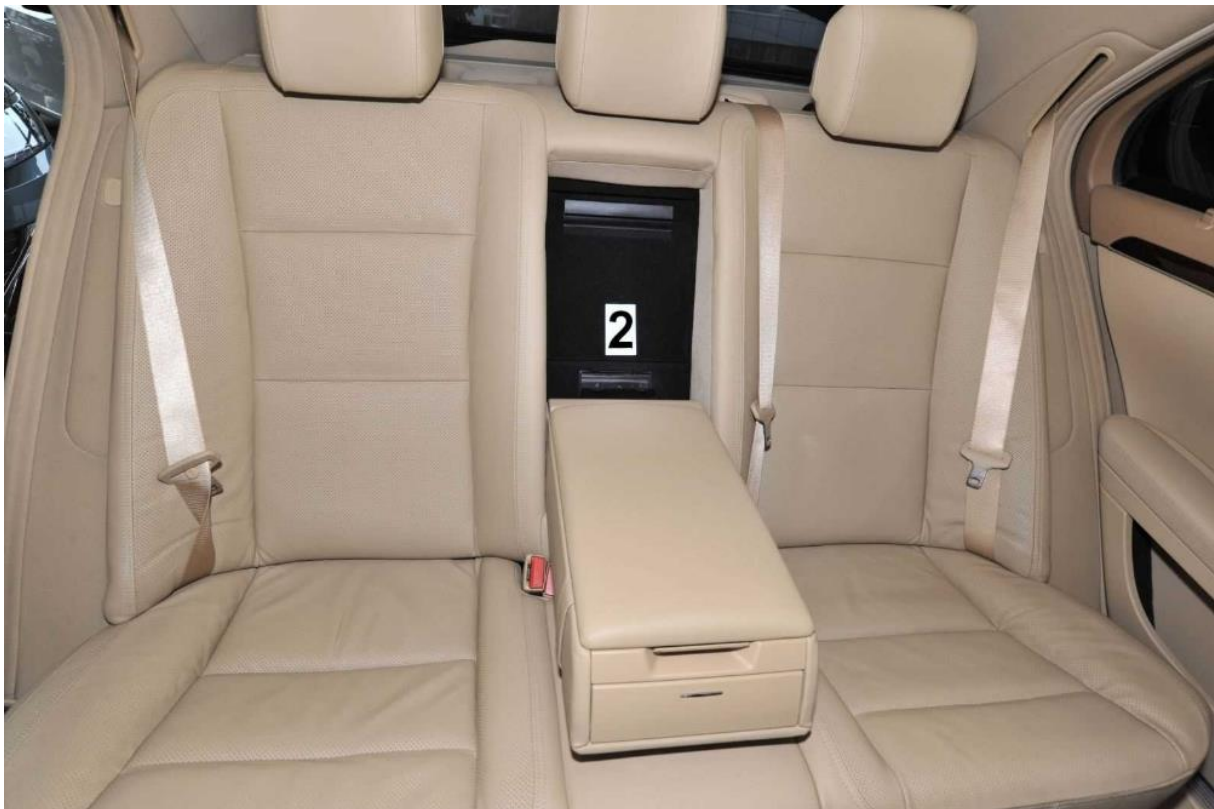
Figure 6. A VIN located in a non-standard way in a Mercedes-Benz S-class vehicle in the space behind the elbow rest of the rear seats. It occurs to hardly anyone to look for the identifier there. On the other hand, this space is clean, dust-free so the identifier is not exposed to the negative effects of ambient phenomena.

Mechanical coverings of a VIN identifier are common if the VIN is inserted in the floor of the vehicle (usually under the front passenger’s seat) or in the inner interior part of the vehicle in the area of the A-pillar (a pillar of the body between the windscreen and front door of the vehicle), in the floor of the vehicle near the front passenger’s legs below the dashboard or on the inside of the door frame above the wheel arch. In some vehicles, the VIN is exceptionally placed behind the folding elbow rest between the rear seats, etc.

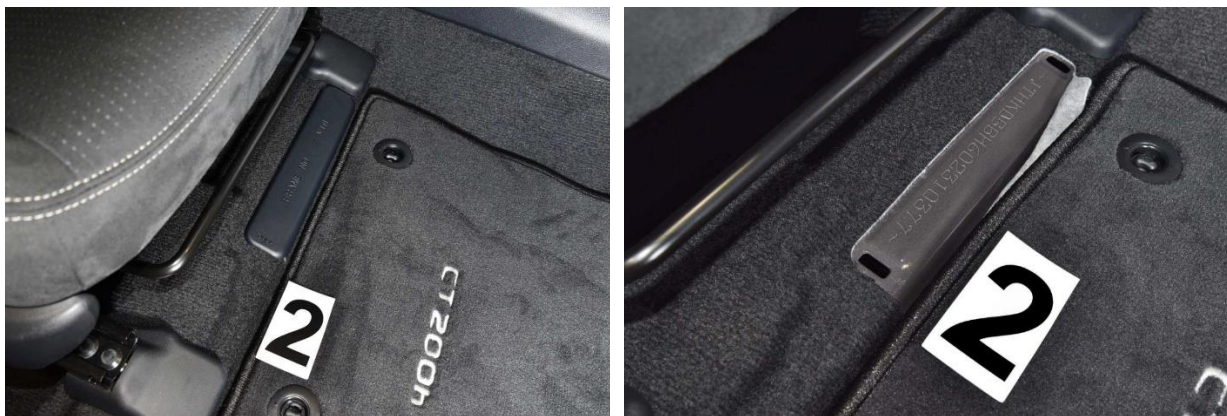
Figure 7. The VIN of a Lexus CT 200h vehicle standardly placed below the front passenger’s seat. The VIN is protected by a plastic guard against damage and soiling.

Plastic guards (predominantly black or grey) tend to be marked with a pressed-in inscription "VIN" or "frame number", etc., in a well-visible way. Plastic guards are designed to be easily opened without the use of great force, or should be carefully "lifted" with a tool similar to a screwdriver. Some hinged guards are slid on the access hole to the VIN, and it is thereby possible to slide them out carefully together with their plastic perimeter frame. In some specific vehicles (currently manufactured luxury Mercedes-Benz S-class vehicles), a plastic guard cover is used to access the vehicle's fuse box, near which a VIN is stamped on the body as well). In such cases, a VIN marking on the plastic guard is absent.

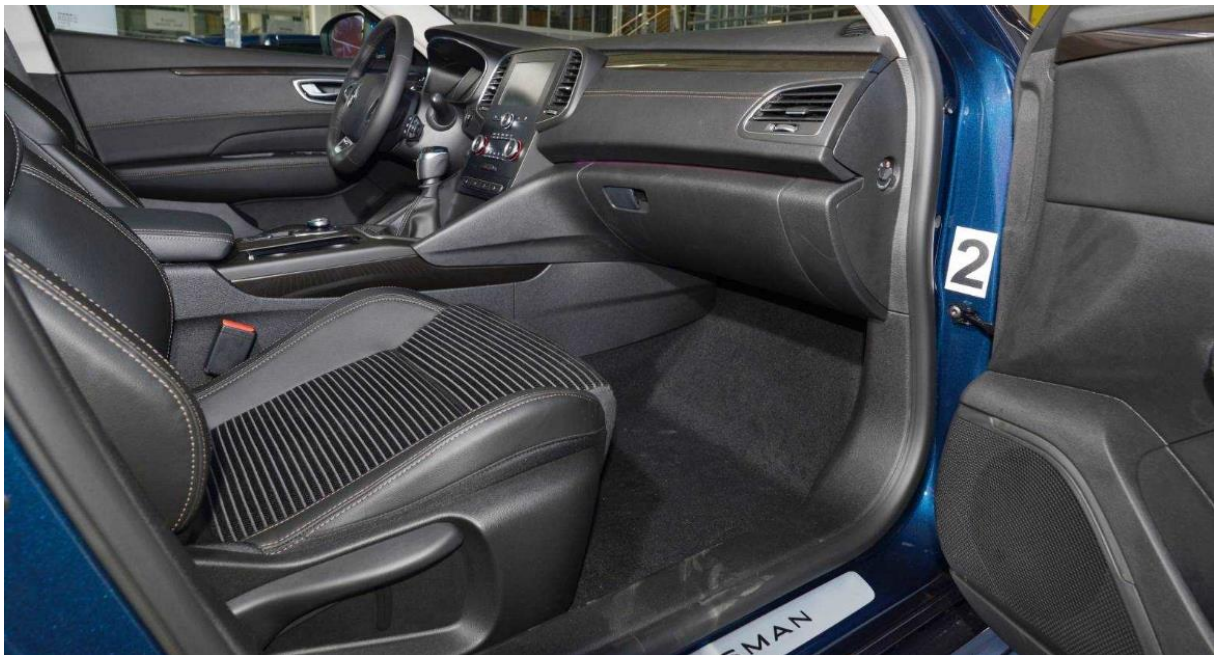
Figure 8. A Renault Talisman. The VIN is positioned unusually vertically in the space of the A-pillar. When the VIN is positioned vertically, dirt, water and service fluids do not cling to it as much.

The extent of potential physical and chemical damage resulting from the operation of the vehicle and the external environs of the vehicle (e.g. climatic conditions) is also affected by the selection of a horizontal or a vertical position of the VIN identifier as well as of other similar identifiers: water and service fluids better flow down vertical surfaces, and dust deposits are less likely to remain there, so the degree of fouling is substantially lower in practice than with identifiers that are placed on horizontal surfaces. With respect to horizontal surfaces, it is appropriate to use various protective coverings with transparent films, the application of various protective paints, wax layers, etc. To better protect the VIN against corrosion, some manufacturers position the identifier vertically into the front (“A”) pillar of the vehicle (some Renault and Dacia models).

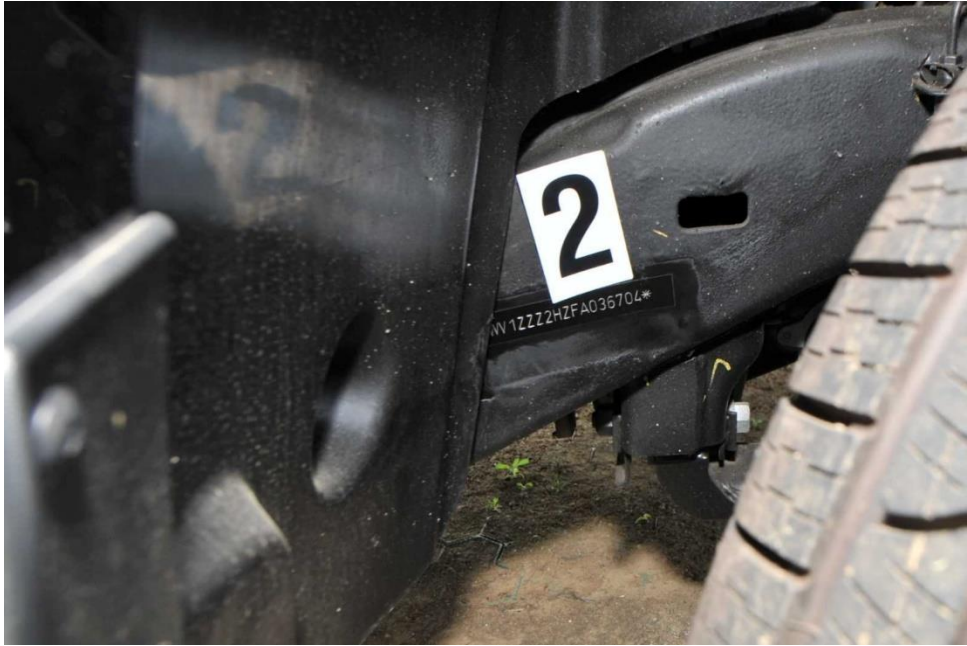
Figure 9. A Volkswagen Amarok. The VIN identifier is located outside the vehicle on its chassis part and is protected by a transparent cover label. Placing the VIN in this part of the vehicle is not too fortunate – comfortable for practical inspection (one has to bend down and, at the same time, turn the wheels), the vehicle chassis tends to be very heavily fouled, so one has to know exactly where to look for the identifier. After several years of operation, the identifier is severely corroded, so its legibility decreases abruptly.

A VIN identifier is more susceptible to corrosion the lower it is placed towards the roadway on an exterior part of the vehicle. Thus, it is exposed to the greatest corrosion if it is stamped into the frame of the vehicle in its chassis part and, at the same time, it is not provided with any further special protection. Some vehicle manufacturers make a VIN identifier without even spraying a bare minimum primer over it.
